# AIRCRAFT GROUND-PLOTATION INVESTIGATION PART VIII DATA REPORT ON TEST SECTION 7

W. BRABSTON and W. HILL, JR.
U. S. ARMY ENGINEER WATERWAYS EXPERIMENT STATION

TECHNICAL REPORT AFFOLTR-00-48, PART VIII
AUG-OF 1906

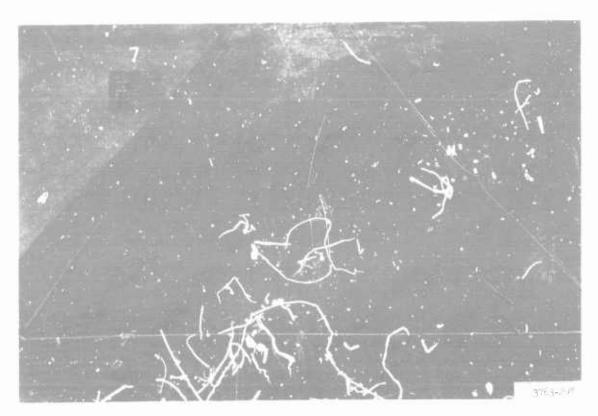
Figure 3 shows lane 13 prior to traffic. The surface was moderately rutted at 20 coverages with rut depths averaging 1.5 in. Traffic was continued until the lane was considered failed due to rutting at 70 coverages (figure 4). The rated CBR of the lane was 9.2.

Figure 3. Lame 13 prior to traffic

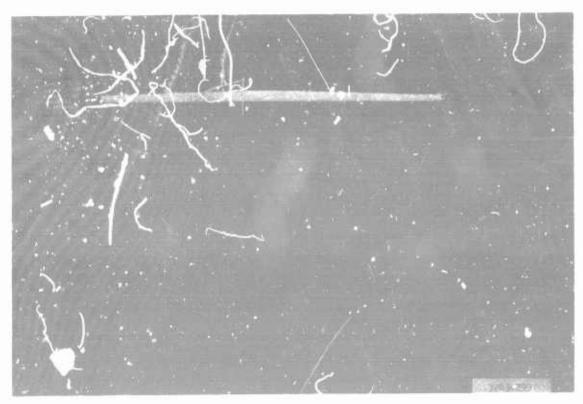
- a. Roughness. Table 1 shows the progressive development of differential deformations and rut depths with traffic. At failure, both transverse and diagonal differential deformations averaged 3.69 in. Longitudinal deformations were relatively small, averaging 0.69 in. Rut depths averaged 3.31 in. at failure.

Figure 4. Lane 13; general view showing transverse straightedge measurement at 70 coverages (failure)

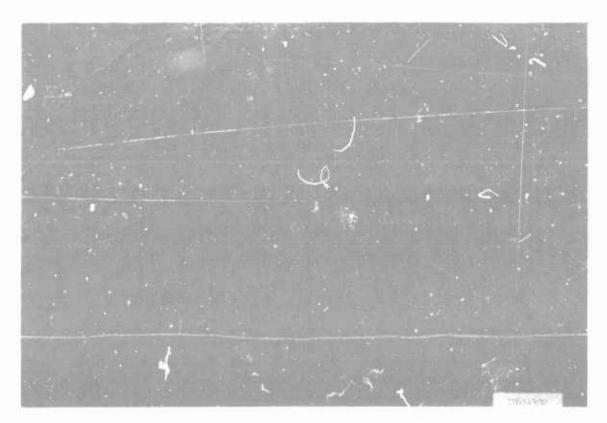
Figure 5 shows lane 14 prior to traffic. The test surface held up well under testing and traffic was continued to 200 coverages at which time the lane was considered failed due to excessive transverse differential

Figure 5. Lane 14 prior to traffic

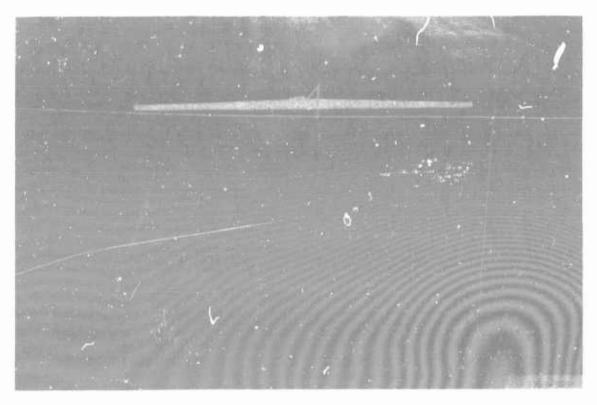
deformations (figure 6). The rated CBR of the lane was 7.8.

- a. Roughness. Table 1 shows the differential deformations and rut depths measured at intervals during testing. Transverse and diagonal differential deformations exceeded in magnitude other deformation measurements and averaged 3.50 and 3.56 in., respectively, at failure. Due to the uniform subsidence in the lane cross section, rut depths were not great and averaged only 1.16 in. at failure.

Figure 6. Lane 14; general view showing transverse straightedge measurement at 200 coverages (failure)

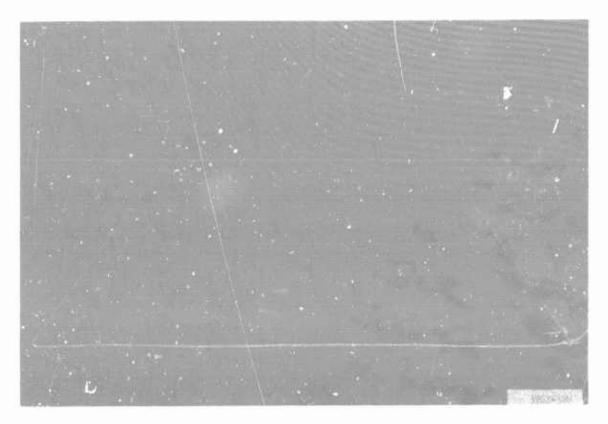
Figure 7 shows lane 15 prior to traffic. The lane was considered failed at 100 coverages primarily due to excessive transverse differential deformations (figure 8). The rated CBR of the lane was 7.3.

a. Roughness. Table 1 shows differential deformations and rut depths measured at 20 and 100 coverages. Transverse and diagonal differential deformations were largest and averaged 3.62 and

3.83 in., respectively, at failure. Rutting was less severe, averaging 2.15 in. at failure.

Figure 8. Lane 15; general view showing transverse straightedge measurement at 100 coverages (failure)

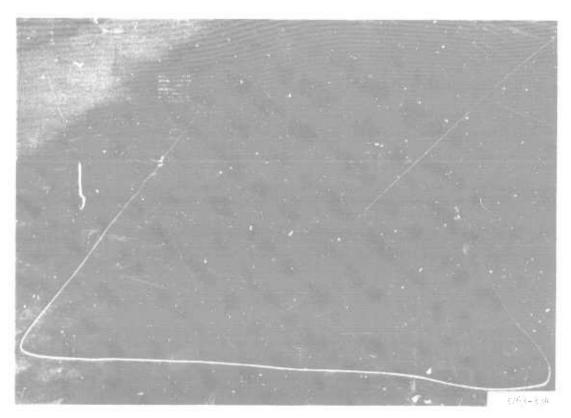
Figure 9 shows lane 16 prior to traffic. Severe ruts developed early in testing with high ridges forming between the ruts. It became impossible beyond 14 coverages to track the ridged strips, as the load wheel continually slipped sideways into an adjacent rut. The relative heights of the ridges increased with continued trafficking due to soil upheaval from the rutted areas. To obtain more representative roughness data, the influence of the ridge areas was de-emphasized by cutting access notches across the ridges so that for differential deformation measurements the ends of the 10-ft straightedge rested on the undisturbed surfaces outside the tracking lane. Figure 10 shows the lane after it was judged failed at 32 coverages. The rated CBR of the lane was 8.4.

Figure 9. Lane 16 prior to traffic

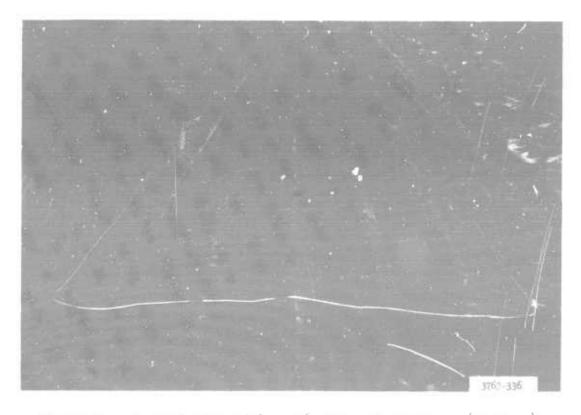
- a. Roughness. Table 1 shows differential deformations and rut depths at 20 and 32 coverages. Transverse and diagonal differential deformations exceeded rut depth measurements, averaging 3.22 and 3.16 in., respectively, at failure. Rut depths averaged 2.07 in.
- b. Deformation. Average cross-section deformations measured at 20 and 32 coverages are plotted in figure 14. The extra ely rough cross section at 32 coverages reflects the combination

of ridges and ruts developed in the lane. Profile plots in figure 15 show the irregular grade that developed from uneven longitudinal settlement.

Figure 10. General view of lane 16 after 32 coverages (failure)
